# NASA TM X-73421

# CENTAUR BOOST PUMP TURBINE ICING INVESTIGATION

by R. J. Rollbuhler Lewis Research Center Cleveland, Ohio 44135 May 1976

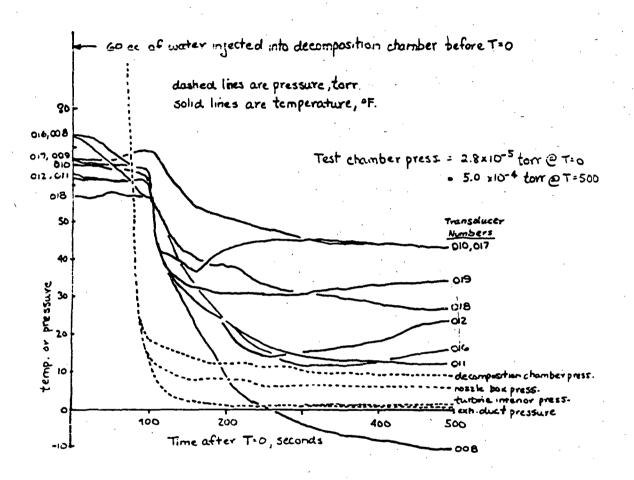
Figure 8 - Typical Boost Pump Test Data (Test No.91)

Data are shown in figure 8 for a typical test in which 60 cc. of water had been injected into the boost pump turbine unit prior to the start of the simulated ascent sequence. At the beginning of the test time = T-0, the unit temperatures were between 60 and  $70^{\circ}\text{F}$ . As the test progressed, the environment pressure gradually decreased from one atmosphere to less than the triple point pressure (4.5 torr) of water. At that time the turbine unit temperatures began to drop. In this test the turbine housing wall temperature at the centerline cooled down the most and reached a minimum temperature of -9°F at an equivalent time of boost pump start (T+440 seconds).

Except for the turbine reactor temperature, the component temperatures indicated a minimum during the test and then reflected a slight increase before the test terminated. See figure 8, also. In such situations it is surmised that most of the ice had melted or evaporated from the surfaces involved and that the bare metal began to warm up due to conduction heat forces. The greater the quantity of water initially in the system, the less this trend for any temperature increase after the minimum temperature was attained. This characteristic would suggest that some moisture could be tolerated in the Centaur boost pump components. The associated evaporative cooling might reduce the component's temperature to below freezing for a short period but the water would evaporate before the vehicle boost pump would be called upon for operation.

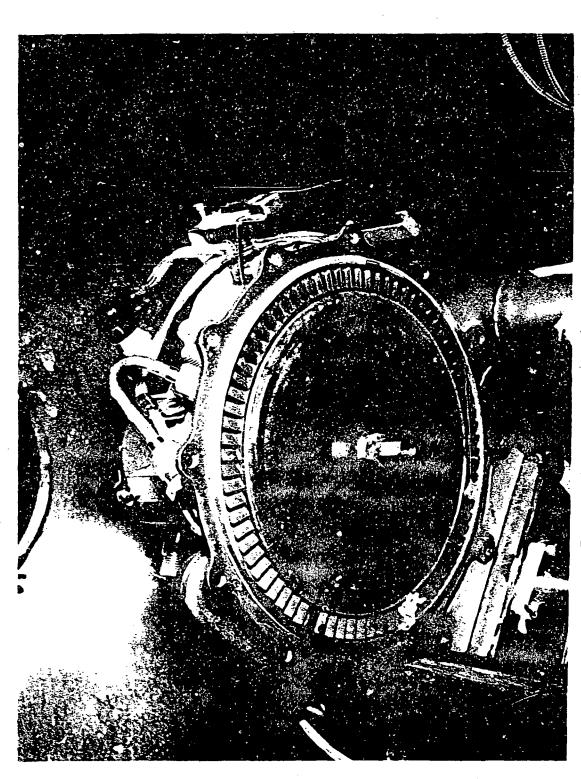
Figure 9. - View of underside of BP building which choice in thindest

Physical evidence of the water vapor forming ice is shown in figures 9 and 10. These are photographs of the boost pump turbine and turbine housing showing the ice formations in the turbine wheel blades and around the turbine housing exhaust duct ports. The photographs were taken immediately after conducting Test No. C23-9B4 in which 30 cc. of water had been injected into the turbine reactor. Once the ice started to melt, such as it is doing in these photographs, the ice liquid film would provide lubrication such that the turbine wheel could begin turning while still containing ice. In a low-pressure, low-temperature space environment condition, however, this ice would have remained hard and would bind itself between the turbine wheel and housing.

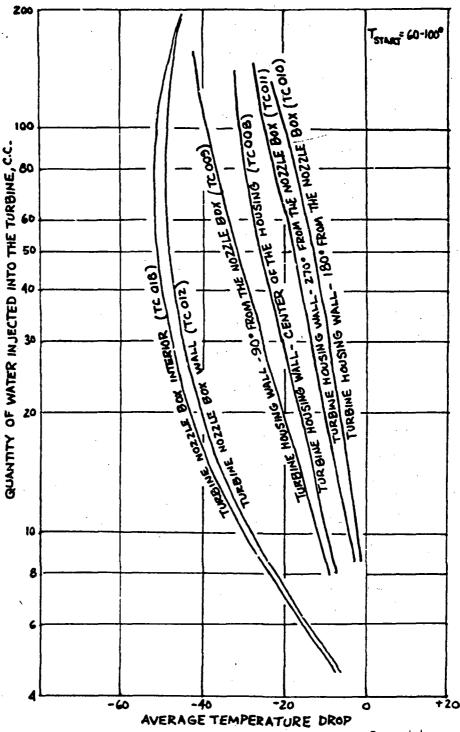
FIGURE 11- Turbine Temperature Change for Various Quantities of Injected Water.

The affect on turbine housing wall temperatures from variations in water quantity in the turbine are summarized in figure 11. The temperature data are presented as the average difference from the beginning of the test until the test termination (T+440 seconds). This averaging does not include the minimum temperature values if the thermocouple indicated an increase in temperature after a minimum had been attained.

however, does have a bearing on the delay time. For the range of water injection quantities tested, the majority incidence of delayed rotation occurred with 50-70 cc. of water. From figure 11 it may be noted that for this quantity of water, the greatest temperature decrease was around the turbine area by the nozzle box. Note also that in Table III the only turbine temperature that was consistently less than  $32^{\rm OF}$  at test termination was location 12 by the nozzle box. All the other turbine location temperatures were below freezing for many of the tests but not all of them.
